Berryman

**Re: Robert Bales and
Danielle Bales,
Plaintiffs,**

**State Farm Fire and
Casualty Company,
Defendant.**

**In the United States District Court
For The Western District of Oklahoma
Case #: 22-cv-00851**

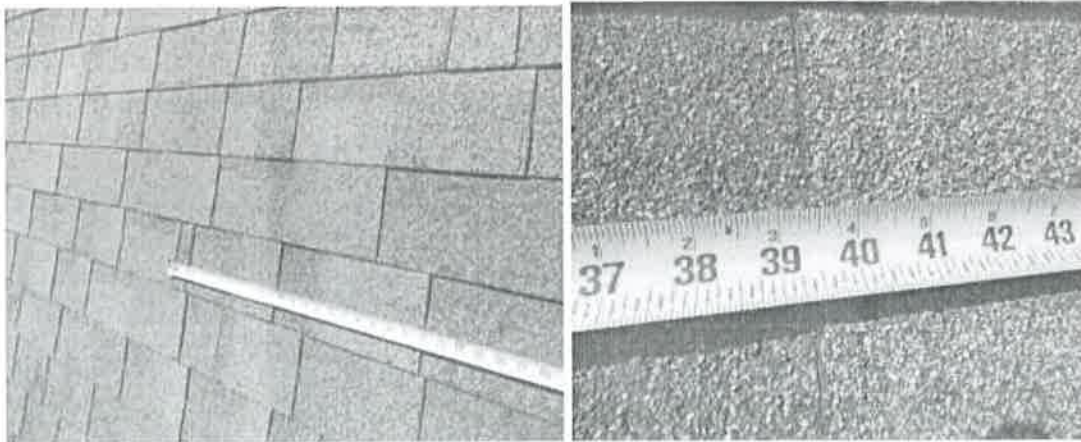
- The shingles are a laminated, composition shingle. Without conducting some manner of destructive testing, the manufacturer of the shingle could not be precisely confirmed. However, the dimensions of the shingles were found to be 39 3/8" wide with an installed exposure of 5.5". Based on these dimensions, the shingle is likely manufactured by one of the leading manufacturers of shingles including: Tamko; Owens Corning; and GAF.

Documentation of the shingle width being 39 3/8"
